# Collaborating to protect municipal infrastructure and restore Redside Dace habitat

Presented by  
Matt Johnston, B. Sc., C.E.T.  
Manager, Erosion Risk Management, Engineering Projects  
Toronto and Region Conservation Authority

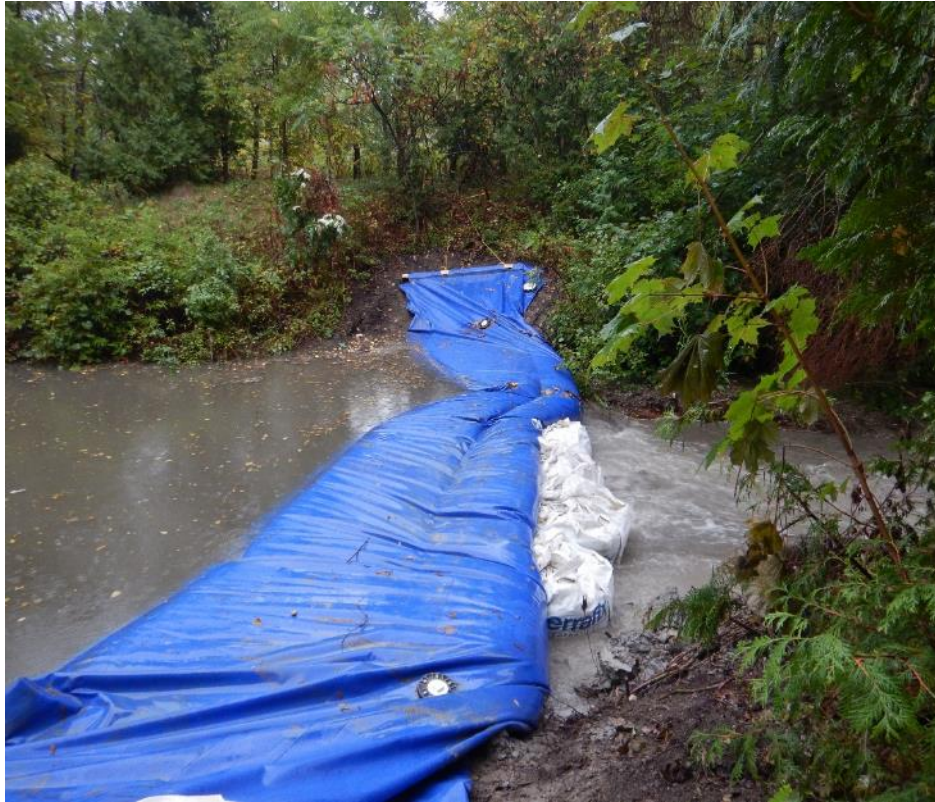
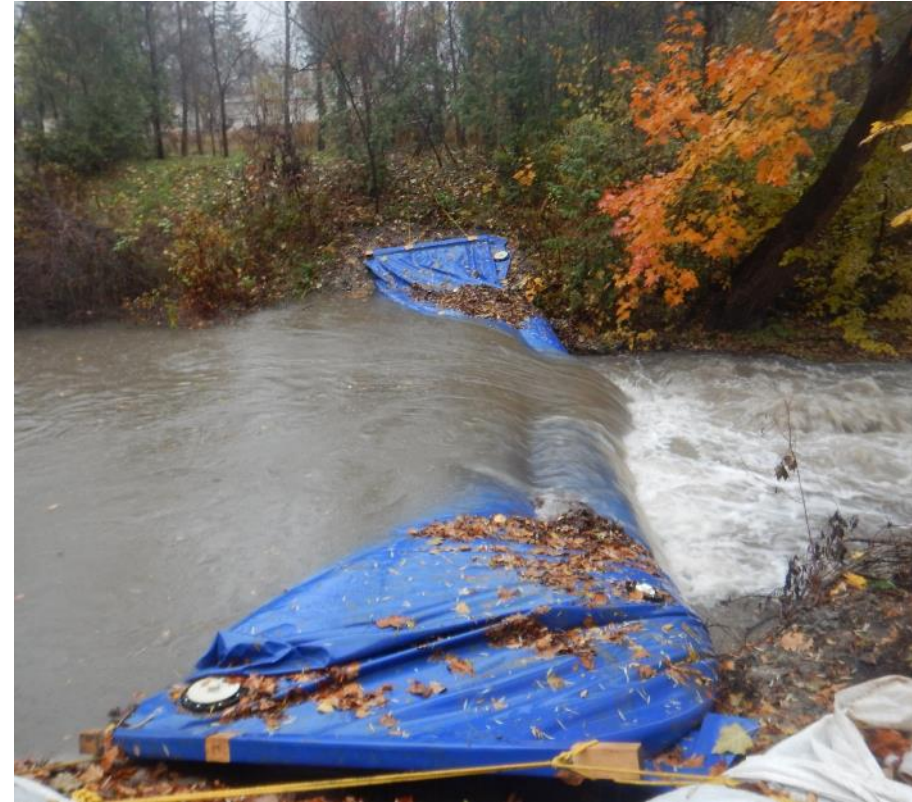
- Trying a new cofferdam product (AquaBarrier) and dealing with numerous rainfall events (2015)

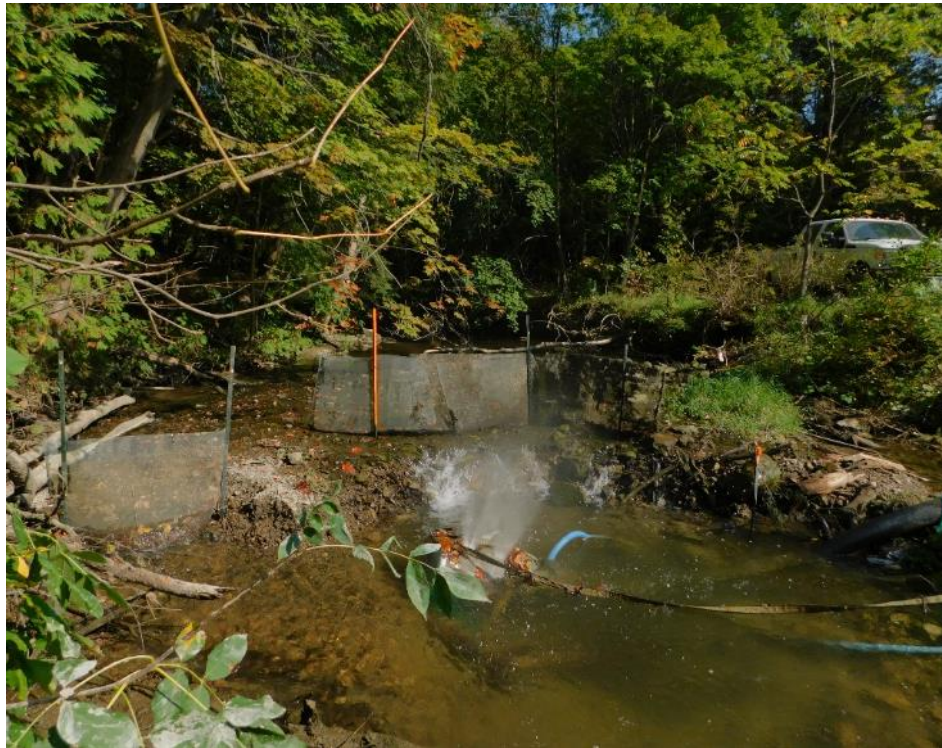
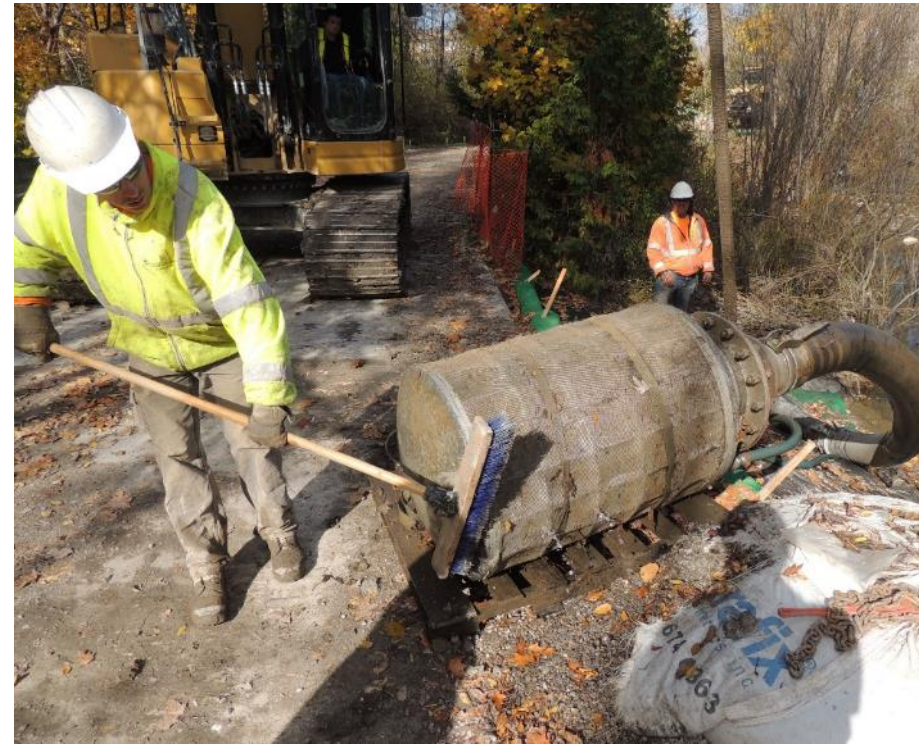
- Maintaining bypass pump intake and preventing debris from clogging the fish screens

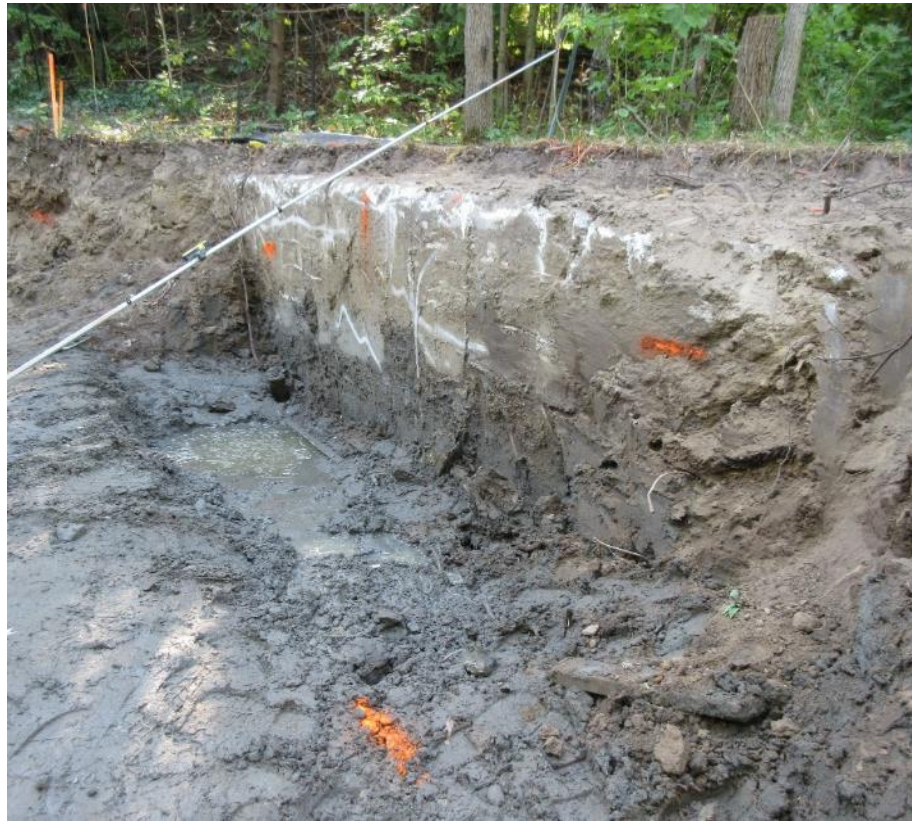
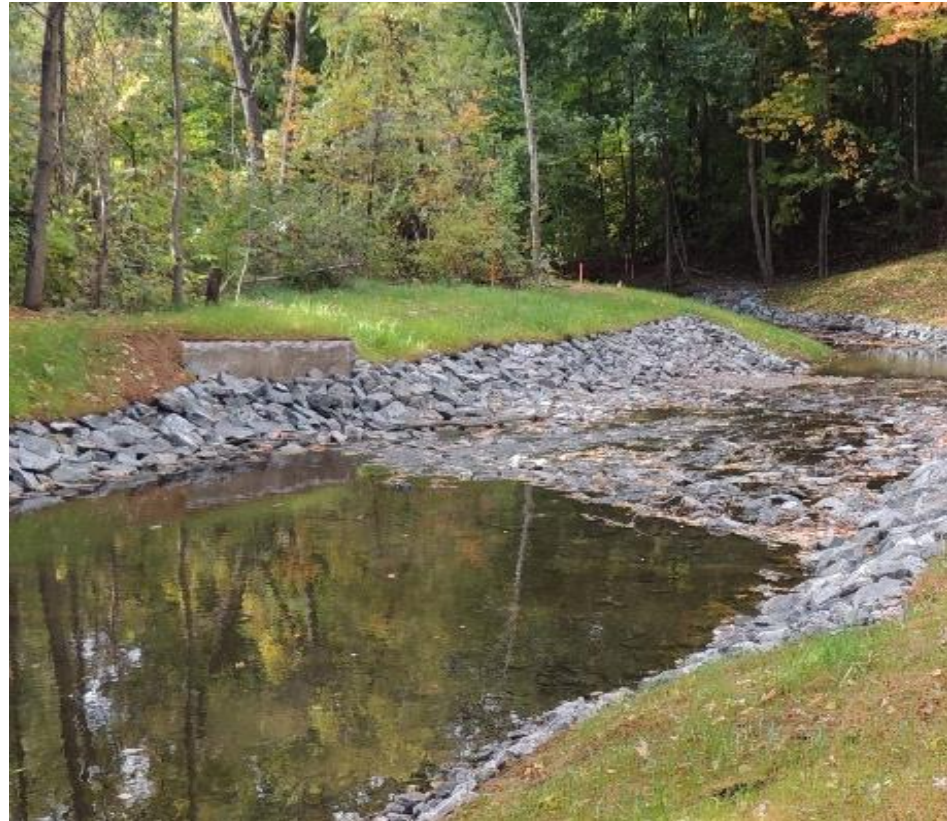
- Encountering unexpected site conditions during construction requiring design modifications

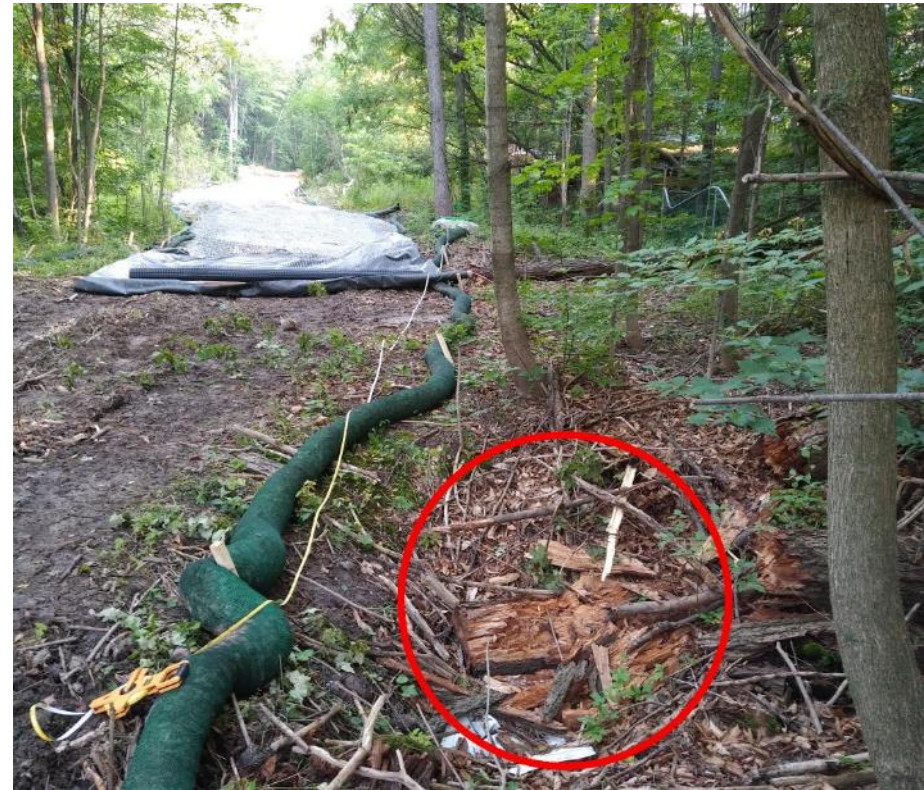
- Deficiencies affecting critical infrastructure along the construction access route

Incident Code: FC  
Incident Description: Fracture  
Circumferential  
Meters: 0015.7  
Position: 3 to 5  
Joint Number: J

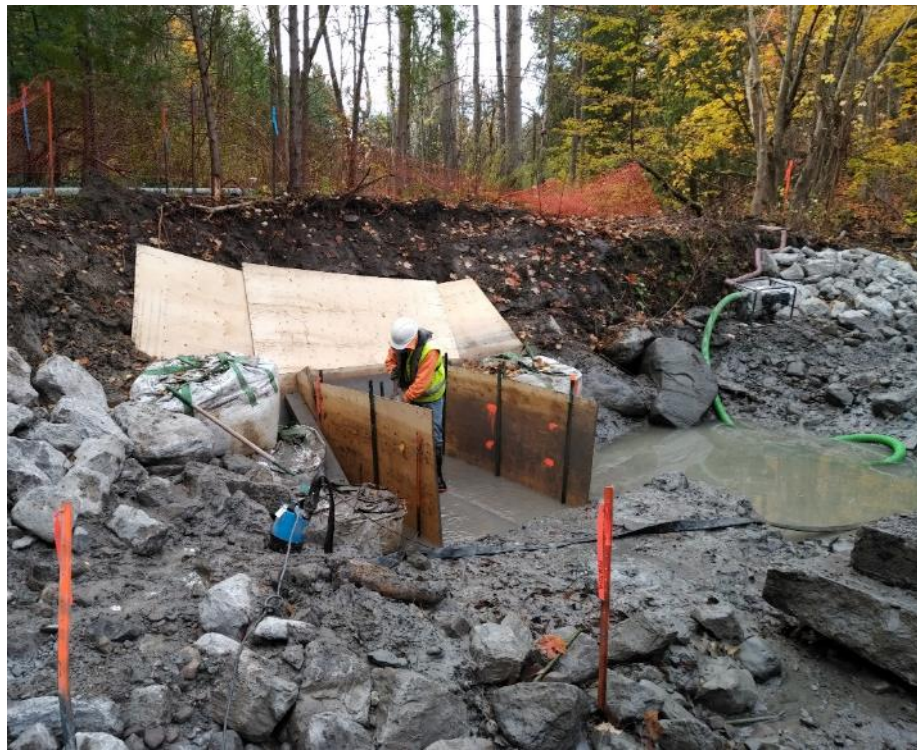
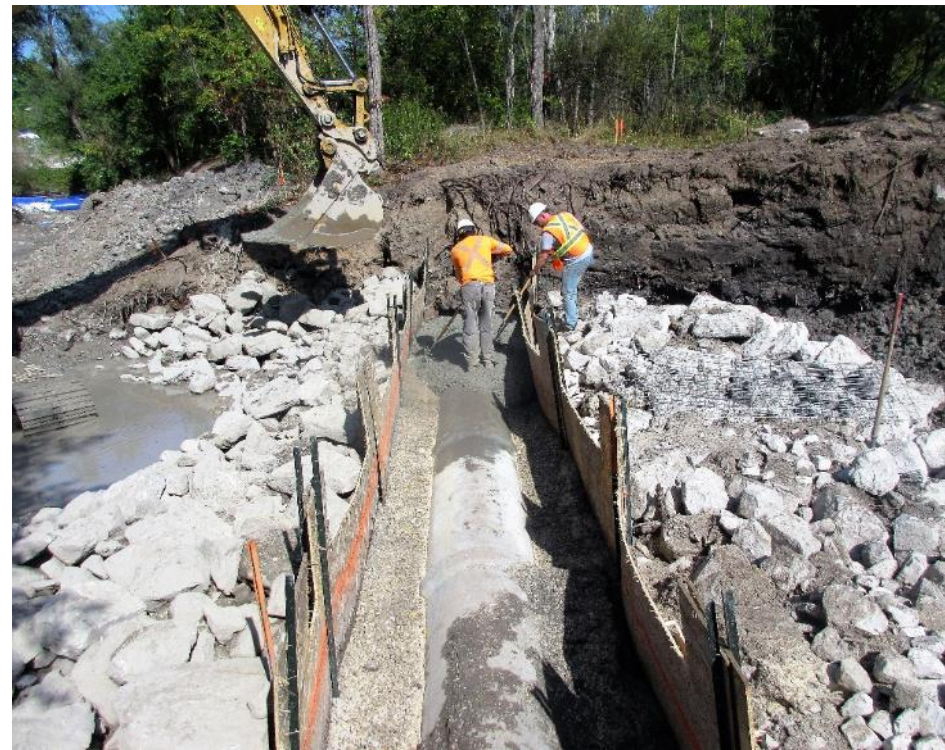
- Encasements originally sized for channel conditions present in early 1970s and didn't extend far enough based on the new channel width
